# Preliminary Assessment

## Crawford Street Site Portland, Oregon

*Prepared for*  
Crawford Street Corporation

June 14, 2000

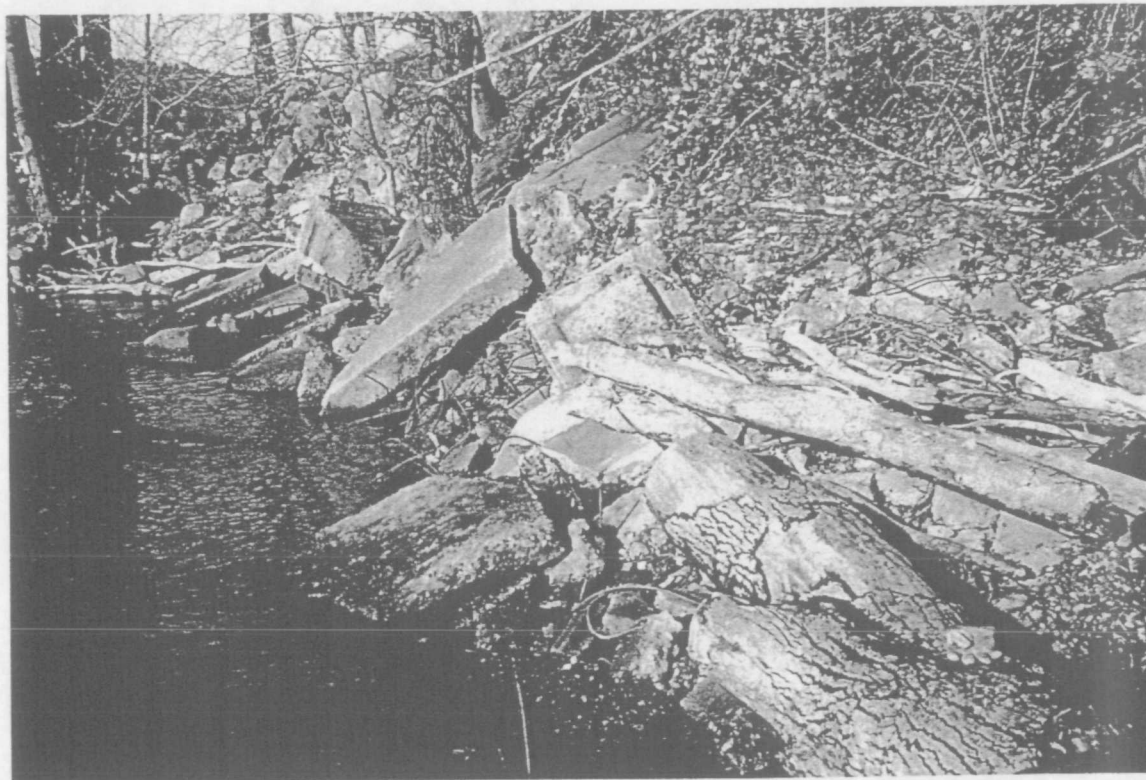
Photo No. 17

The riverbank is vegetated with blackberries and small trees. Most of the bank is covered with concrete debris and logs. Some of the concrete debris is larger than 6 feet with logs greater than 20 feet long. Smaller asphalt debris was also observed on the riverbank. Although the vegetation limited the ability to closely observe, no seeps were observed along the riverbank during the site reconnaissance. A nominal 8-inch diameter concrete pipe was observed protruding from the riverbank about 200 feet east of the western boundary of the CSC site. No evidence of recent flow from the pipe was observed (even after recent wet weather) and the pipe appeared to be associated with previous uses of the CSC site.

Typical river bank conditions.

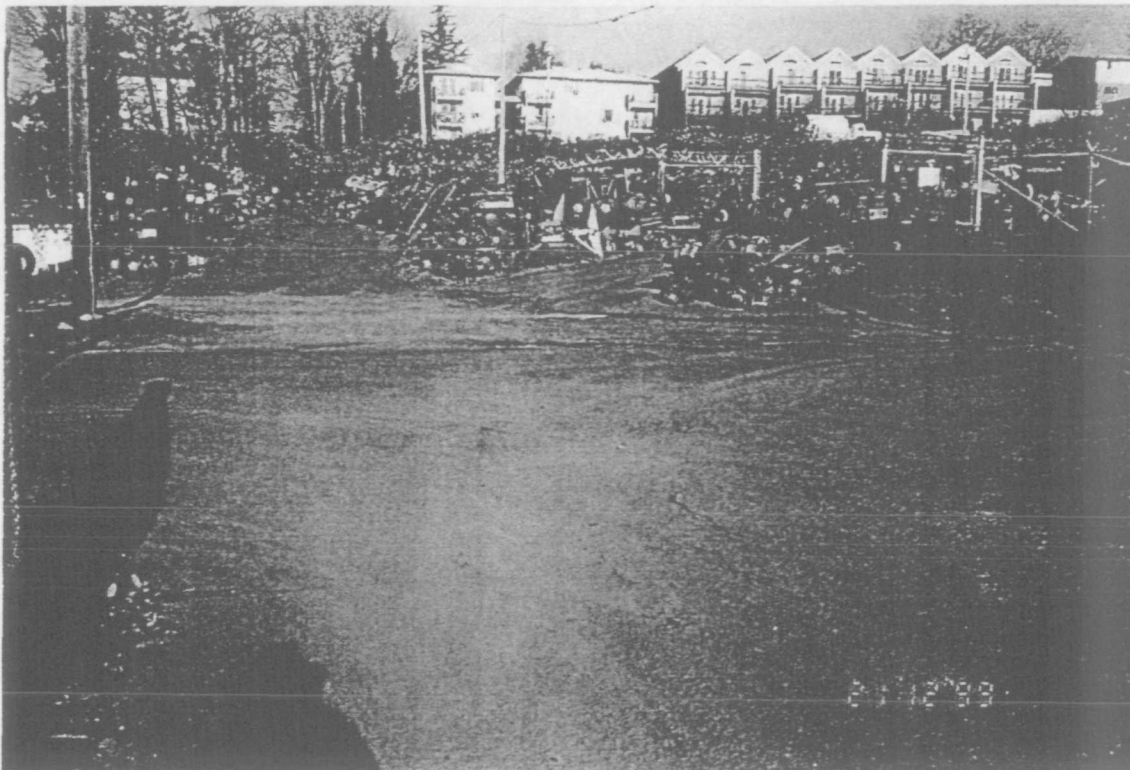
**Photo No. 18**

Looking north from north side of Columbia Forge/Lampros Steel yard at St. Johns Truck and Equipment debris yard. Storm water runs from this area, across Crawford Street, and on to and across the storage yard.

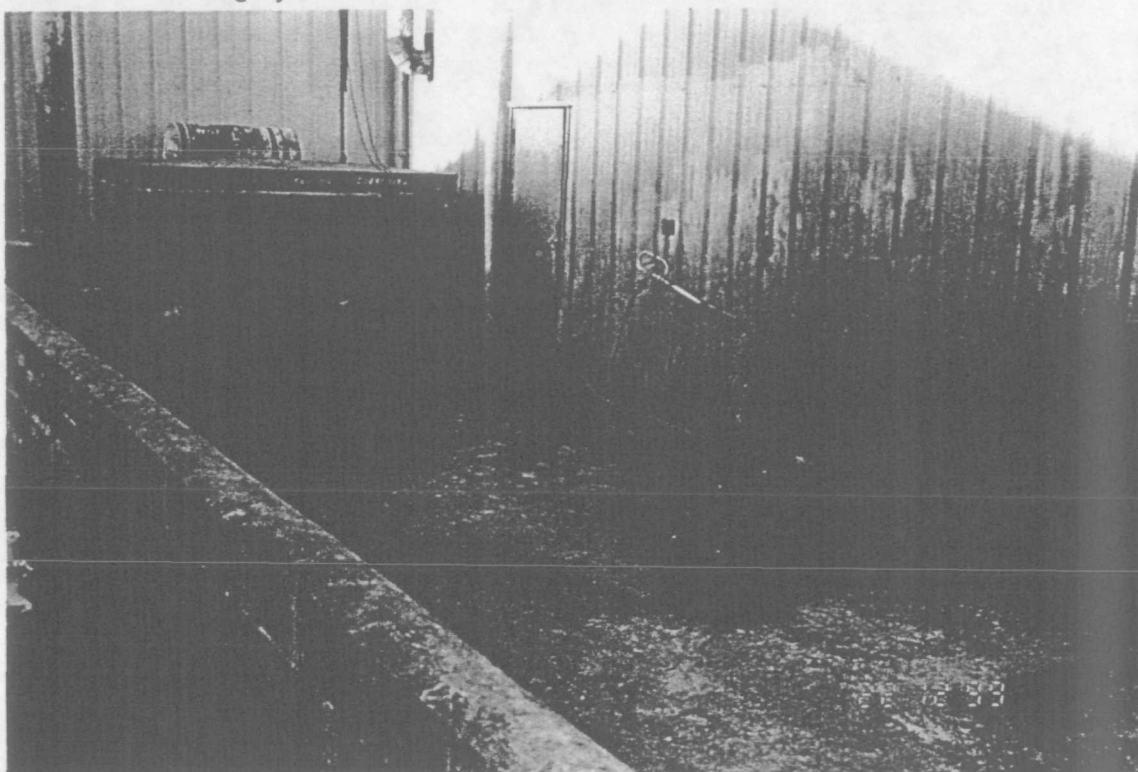
**Photo No: 19**

A heavily stained, uncovered wash pit is present immediately adjacent to North Crawford Street, across the street from the Columbia Forge office.

The approximate 15-foot by 30-foot area drains to a sump that presumably drains to the local storm water or sanitary sewer system. The concrete floor in the wash pit was heavily stained with petroleum hydrocarbons. What appeared to be a solvent cleaning tank was also located in the wash pit. Any releases from the solvent tank would also flow directly to the drain.

Stained wash area adjacent to Crawford Street at St. Johns Truck and Equipment. Across Crawford Street from Columbia Forge.

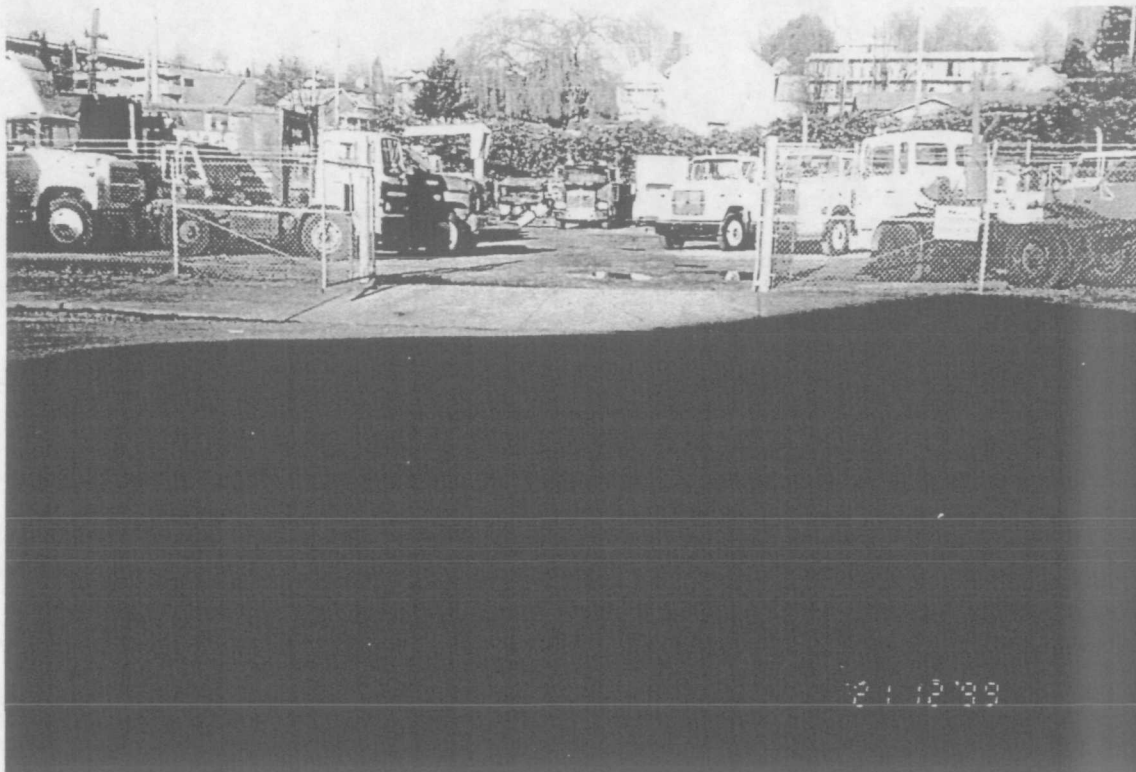
**Photo No. 20**

The western portion of this up gradient property (across from Lampros Steel offices) is also used to store trucks. Oil stains are present on the unpaved ground where the trucks are stored. Torch cutting of disassembled truck parts is also being performed in this area.

Looking north at St. Johns Truck and Equipment truck storage yard. Storm water runs from this area, across Crawford Street, and on to and across the Lampros and TLS Steel areas.

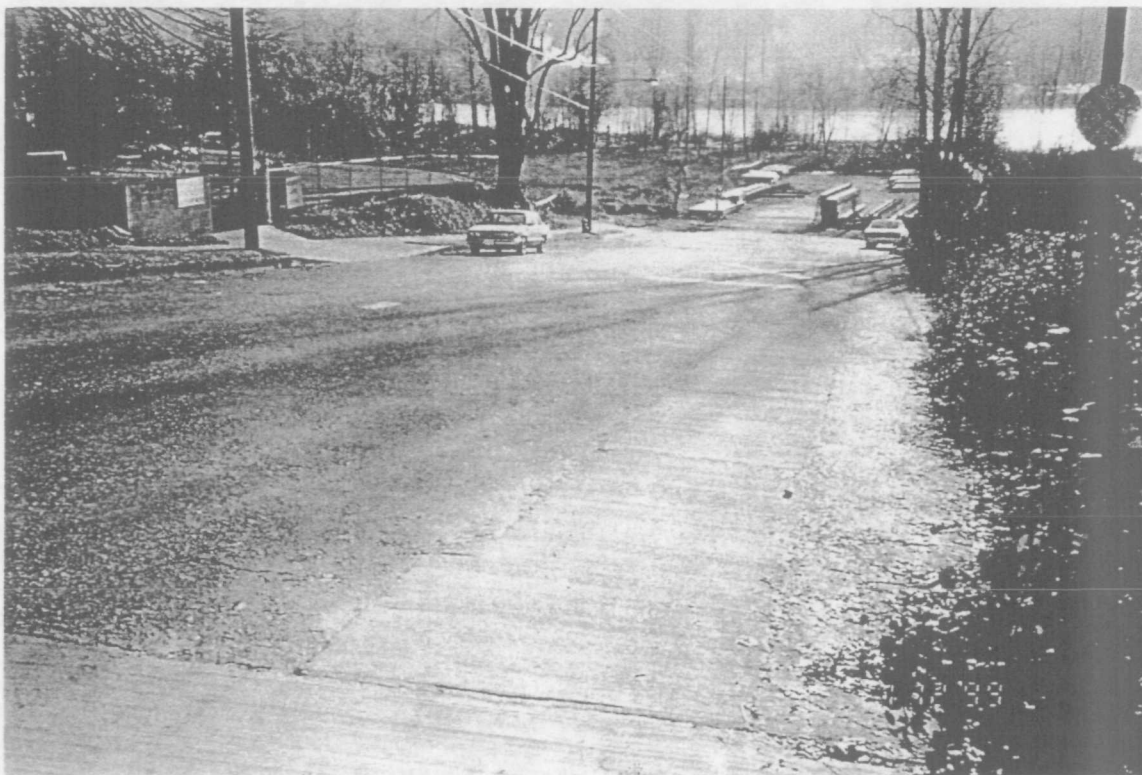
**Photo No: 21**

Looking south down North Richmond Street. Storm water flows down this street to UPRR rail spur area and to the Lampros Steel south storage yard.

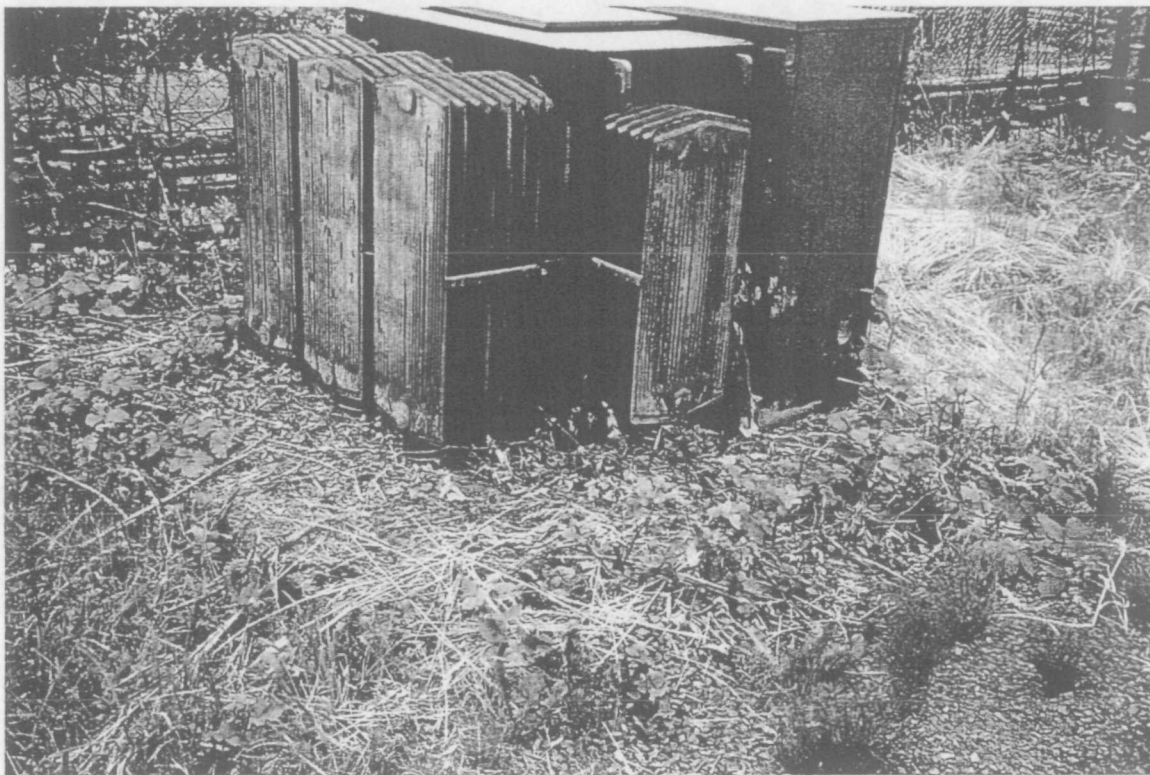
Photo No. 26

An electrical transformer is located on a 5-foot by 5-foot concrete pad in southwest portion of the Columbia Forge operations yard. There was no staining on the exterior of the transformer or the concrete pad or any other evidence of leakage from the transformer.

Transformer in southwest portion of Columbia Forge operations yard. Looking southwest.
